## 10ft deep leak on plastic pipe is no match for FIDO

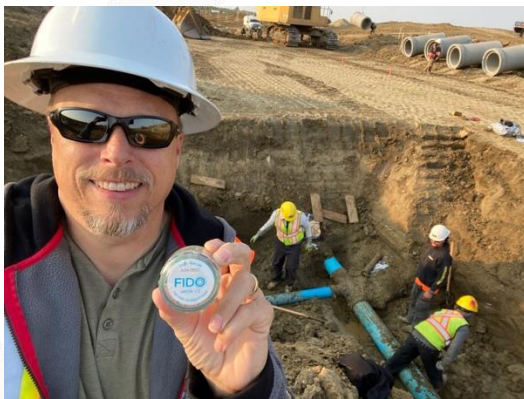
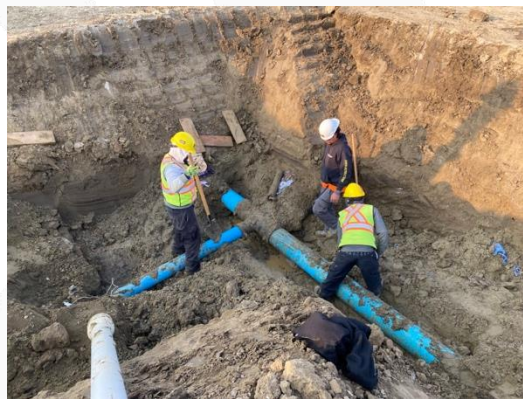
The excavation crew carried out the dig with guidance from FIDO AI, and the 10ft deep leak was confirmed at the precise location as indicated.
